# Huron Pines

## Hodges Creek/Black River Road—Montmorency County

*December 2009*

## Reducing Erosion and Protecting Brook Trout

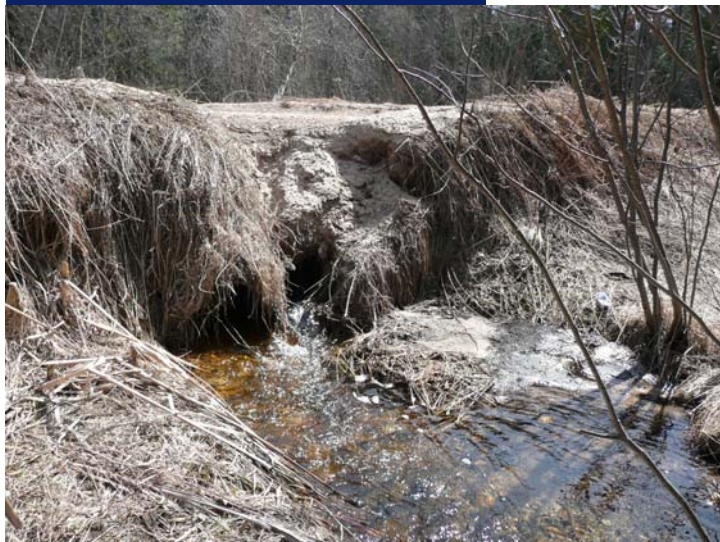
B  
E  
F  
O  
R  
E

*Left: The original culvert was restricting water flow and hindering fish passage. Right: Before work began, sand-laden runoff went directly into the river.*

The new culvert, chosen for its capacity to span the entire stream width was also lengthened to reduce the steep embankment and resulting erosion. Originally there were two 24 inch culverts at the site, though only one of them was allowing water to flow through. These culverts were replaced by one 60' long by 6' wide span elliptical culvert. The culvert was also "recessed" and fieldstone was placed in the bottom of the culvert by volunteers from the Upper Black River Restoration Committee to create a more natural streambed. In addition, the sand road was hardened with a crushed limestone aggregate. Hardening the road surface, replacing the culvert and protecting the embankment, has resulted in sediment reduction of 5 tons/ year and 26 river miles have been opened for fish passage.

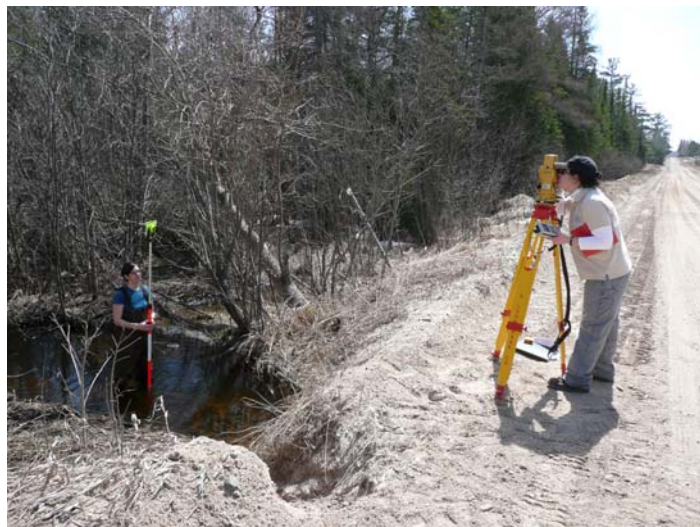
*NRCS Engineer, Andrea Paladino, and Huron Pines AmeriCorps member, Casey Ressler, gather survey information for the road crossing site design.*

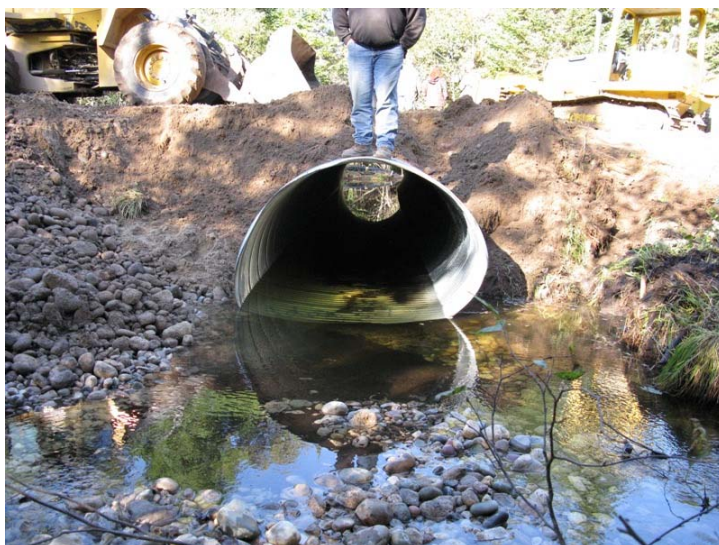
A  
f  
t  
e  
r

*Left: The new culvert is set in place by the Montmorency Road Commission.  
Right: The 6' wide culvert has reconnected 26 river miles for fish passage.*
